AGUA HEDIONDA LAGOON

CAULERPA TAXIFOLIA ERADICATION PROGRAM

SPRING 2002 REPORT

Merkel & Associates

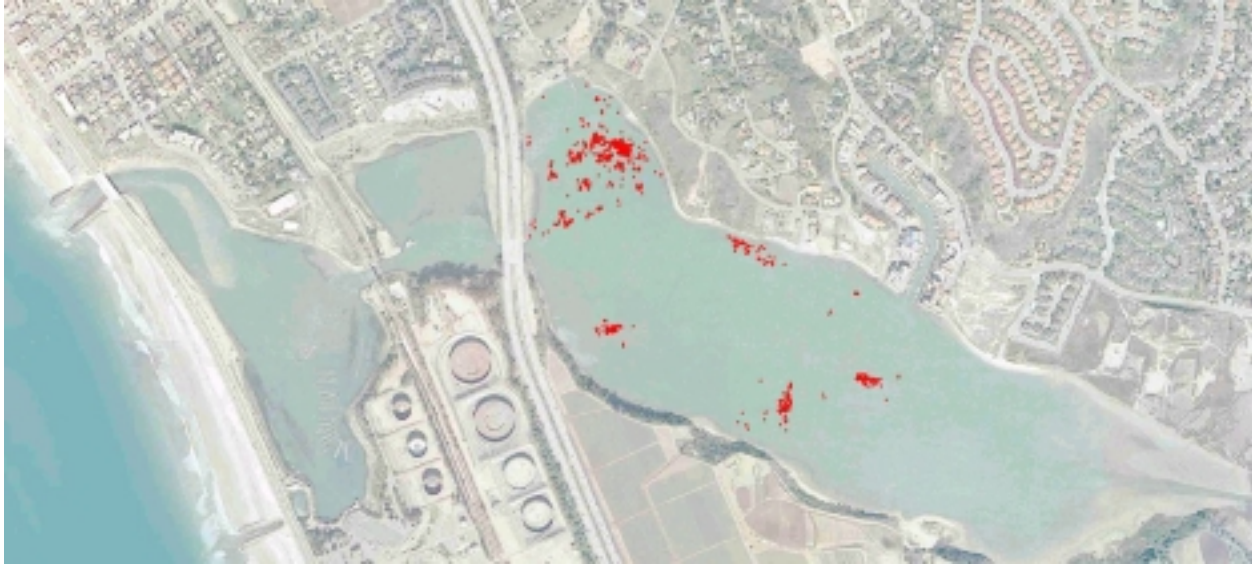
Historical Distribution of *Caulerpa taxifolia* in Agua Hedionda

Cumulative distribution of *Caulerpa taxifolia* from June 2000-May 2002. *Caulerpa* has not been found in the west or central basins of the lagoon during this eradication effort

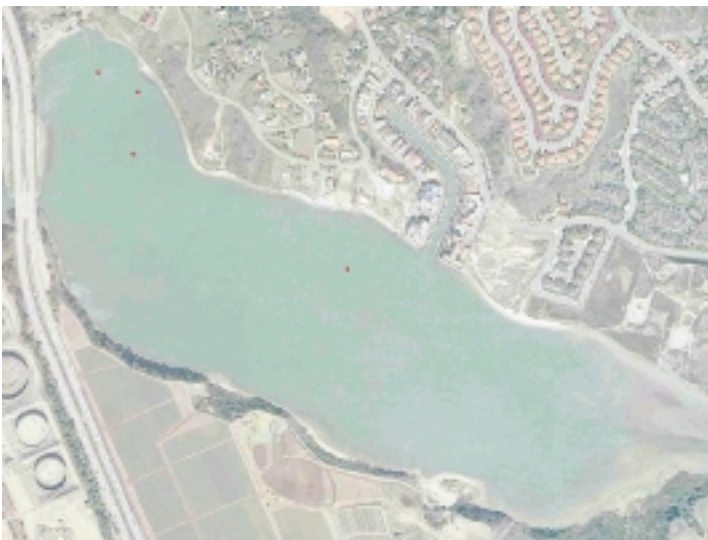
Spring 2002 Update

During the Spring 2002 survey of the entire lagoon, four small patches of *Caulerpa taxifolia* were found by divers totalling an area of 5.8 ft² at the locations indicated above.

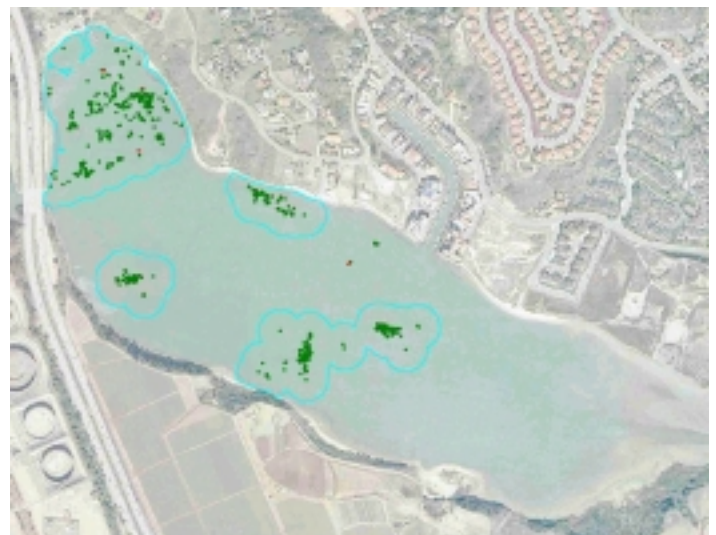
Cumulative distribution of *Caulerpa* (new finds in red) with 150 ft. buffers drawn around all known finds. This buffered area is considered the "infestation area". Newly discovered small patches are typically associated with previously identified core patches and fall within these infestation areas.
